How to..... service and/or fit a replacement diaphragm to the Alfons Haar type SF 1 inflatable boat RIB inflation valve

Servicing the Alfons Haar SF1 Inflation Valve:

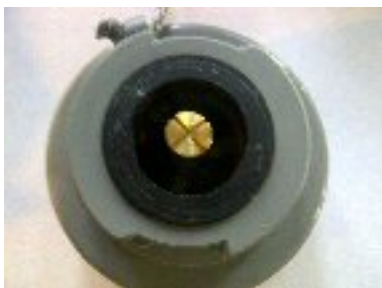
Deflate the tube or collar by removing the cap by twisting counter-clockwise a ¼ turn and depressing the brass diaphragm spindle down and turning anti-clockwise until the diaphragm is in the locked open position. Remove and keep safe the black rubber seal (do not unscrew the upper valve body as the lower valve body may be lost inside the collar/tube)

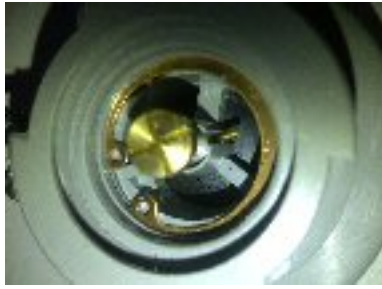
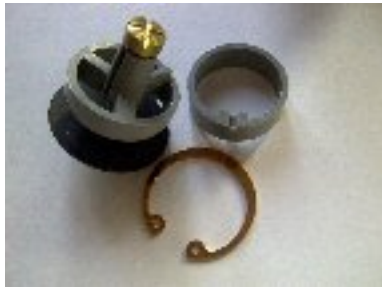
Using a pair of circlip pliers, remove the large gold coloured circlip from the body of the valve and then slide up and out, the complete spindle/diaphragm assembly from inside the valve body.

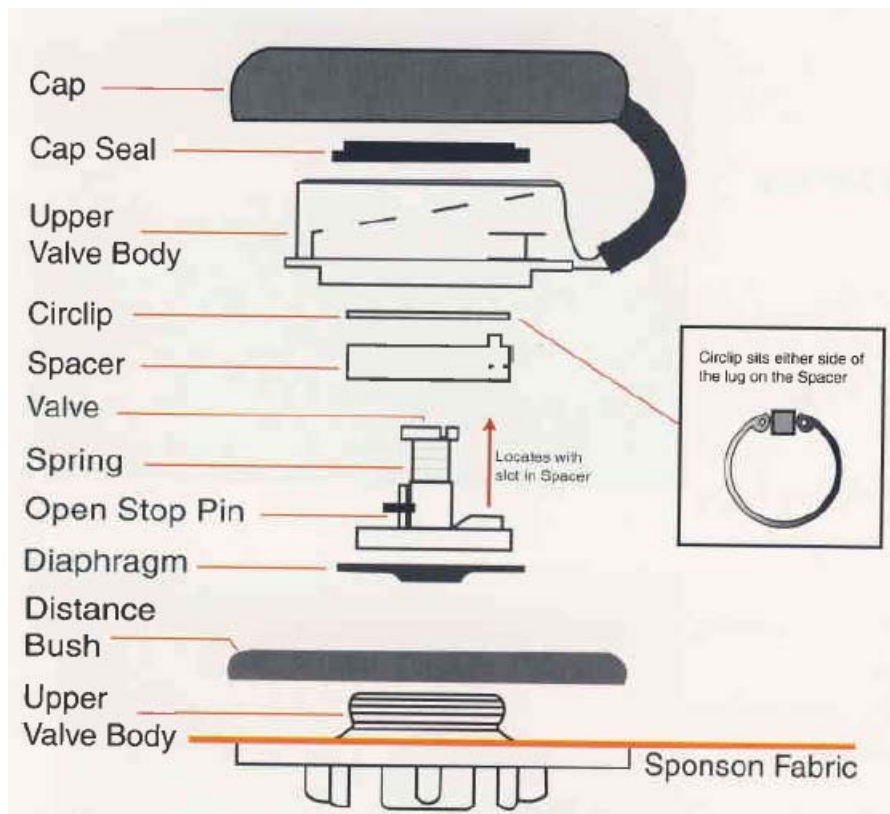
Inspect the rubber diaphragm for any damage, dirt and/or grit, or for any hardening of the rubber that prevents a good seating of the valve. Ensure that the spindle is in the closed valve position and depress the brass spindle to check the free operation of the spring, inspect for any damage of the brass spindle, spring and plastic fittings. If any damage or failure to freely operate then replace the diaphragm assembly (service kit available at www.ribstore.co.uk/shop SKU product ref 1892)

Otherwise, clean the diaphragm assembly with soapy water and when dry reassemble the valve. Ensure that the spindle is in the closed position before re-inflating and replacing the cap.
